INCORRECT MAINTENANCE

Aircraft Maintenance Manual (AMM) MBB BK117-C2

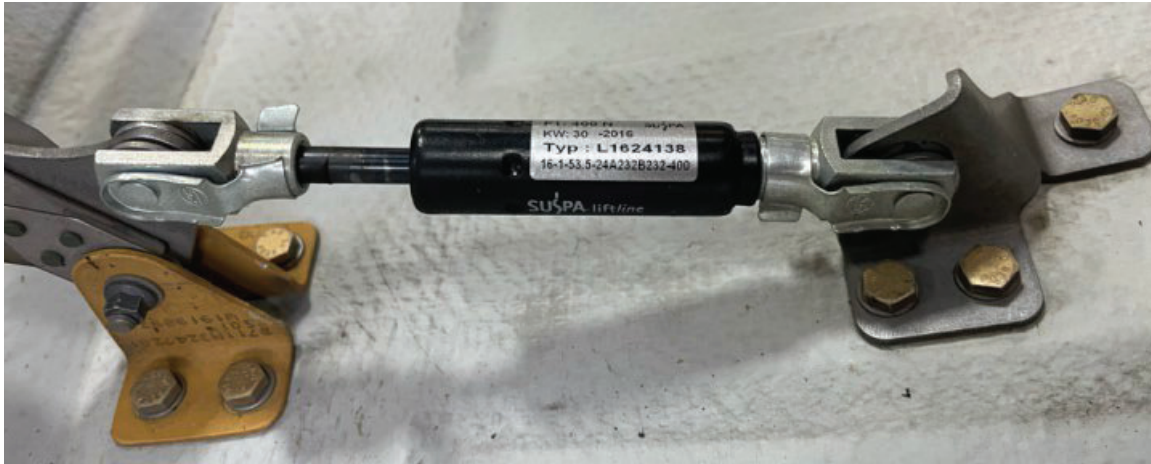
Several installed cowling gas springs have been discovered to be incorrectly installed. Maintenance personnel incorrectly installed the gas springs using the shipping hardware, instead of the hardware called out in the AMM. Incorrectly installed gas springs can be identified by inspecting for excessive play / sloppiness in the clevis. If you identify incorrect installed hardware, correct the deficiency immediately by installing the correct hardware called out in the AMM.
