PREVENTIVE MAINTENANCE MONTHL

ISSUE 788 JULY 2018

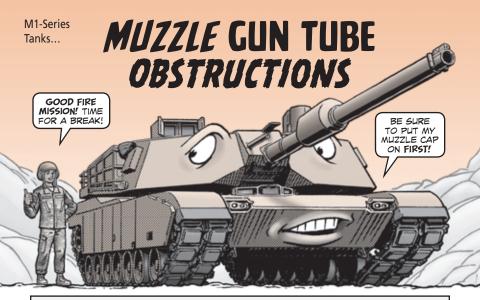
I've noticed some tank crews don't take the time to put a muzzle cap on their M1-series tank's gun tube when they're not firing.

Sand, dirt and other debris tend to find their way into the gun tube, especially during operations. Firing a round through an obstructed tube can cause the tube to bulge or even explode!

- Always use the muzzle cap when the main gun isn't being used.
- When necessary-like during emplacement-keep the main gun elevated to keep it from hitting the ground.
- Check the gun tube for obstructions before firing.

If you find an obstruction, clean the gun tube. You'll find the procedures in the -10 TM.

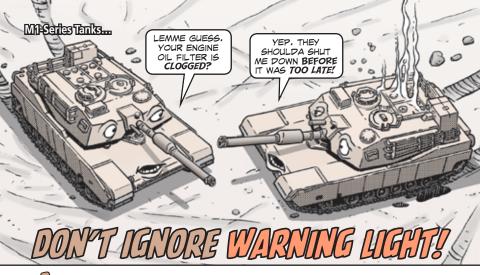
Privers, an ENGINE OIL CLOGGED FILTER warning light turning on in your M1-series tank is bad. Even worse is continuing to operate your tank after the warning light comes on.

When the clogged filter warning comes on, dirty oil is bypassing the filter and that means dirty oil is being recirculated. That's bad news, because the dirt, sand and other gunk that's in the oil can seriously damage the engine. The bypass feature is to keep the engine running only when you're on the battlefield.

Mechanics, if the light stays on after changing the filter element, the problem is probably a bad by-pass pressure switch on the engine oil pump assembly. Replace the switch with NSN 5930-01-089-9142.

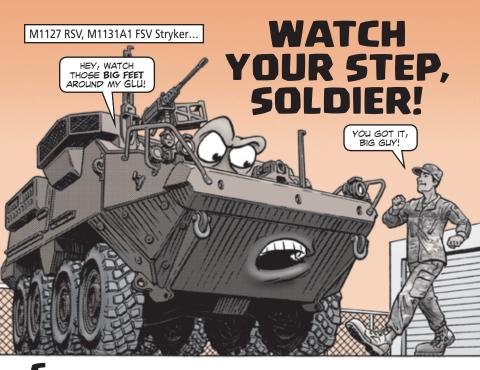
Lrewmen, tread lightly when getting in or out of the commander's cupola in your M1127 RSV and M1131A1 FSV Strykers. One wrong step and you can do some heavy damage to the grenade launcher unit (GLU).

Switches and switch guards can be broken on the GLU, NSN 1055-20-001-7712, when crewmembers are careless with their feet. Replacing the GLU will set your unit back nearly \$2,500. So be careful where you put those feet!

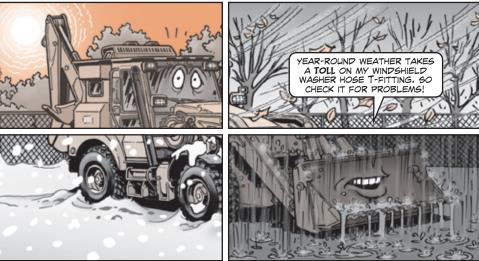
O perators, a loss of windshield washer fluid usually means one of two things: Either your HMEE-1 excavator with add-on armor is out of washer fluid or the washer hose T-fitting that connects the rubber hoses is missing or cracked.

This plastic fitting is right next to the windshield and constantly exposed to the elements. Over time, the fitting becomes brittle, cracks and then breaks apart. Without the fitting, there's no washer fluid. And peering through a dirty windshield can be dangerous!

Order a replacement T-fitting with NSN 4730-01-621-0483. It costs less than a buck and is shown as Item 12 in Fig 11 of TM 5-2540-236-13&P (Jul 16). Do your unit a favor and make sure to keep plenty of the fittings on hand.

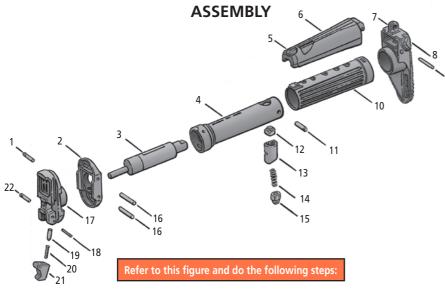
- 1. Remove buttstock assembly from weapon.
- 2. Fully extend collapsible buttstock assembly.
- **3.** Remove **cheekrest** (6) from buttplate and **stock assembly** (10) by loosening **thumbscrew** (5) from cheekrest. Do not completely remove **thumbscrew** (5) from cheekrest.

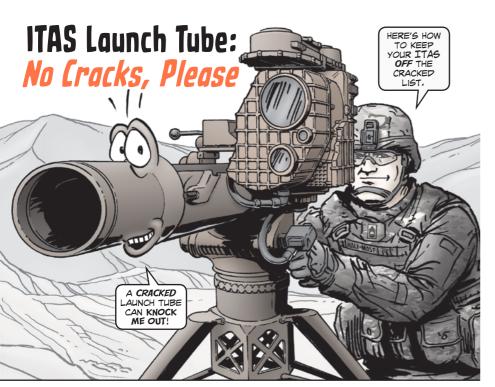
We recently did a technical inspection of our Improved Target Acquisition System (ITAS) systems as part of an upgrade and found 17 of 24 launch tubes cracked.

A cracked launch tube deadlines ITAS because it hurts ITAS's ability to launch and track a missile to its target. At \$2K a pop, it's not cheap to replace them.

Never put anything on top of a launch tube, especially for travel. The weight and bumps in the road can quickly crack the tube. Use the HMMWV's storage location!

Never store the launch tube upright in the tripod. Why? If the tripod tips over, the tube takes a hit. CRACK. The tripod legs also have pins inside that can dent and crack the front of the launch tube. When you're not in the field, store the tube on a shelf or in its shipping container.

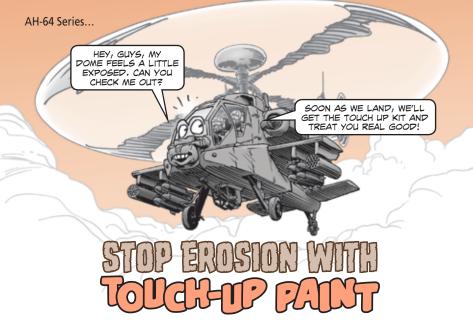
MECHANICS, APACHE AIRCRAFT WITH FIRE CONTROL RADAR (FCR) MAST MOUNTED ASSEMBLY (MMA) RADOMES ARE EXPERIENCING **PAINT EROSION.** IN SOME INSTANCES, THE EROSION IS **SEVERE** ENOUGH TO EXPOSE THE RADOME'S RESIN OR QUARTZ MATERIAL.

IF LEFT **UNTREATED**, THE EROSION CAN **WORSEN** AND **DEGRADE** THE RADAR'S PERFORMANCE. THAT'S WHY IT'S IMPORTANT TO TREAT EROSION SPOTS **WHEN THEY OCCUR**. LISE THE **APPROVED TOUCH-UP KIT**, NSN 8010-01-580-7167 (PN CRC6848R3) TO **PREVENT** FURTHER EROSION AND PERFORMANCE PROBLEMS.
